WL-TR-92-4079

## Internal Structural Characterization

General Electric Aircraft Engine  
Quality Technology Center  
One Neumann Way  
Cincinnati, OH 45215-6301

Final Report for 09/01/88 - 03/30/92

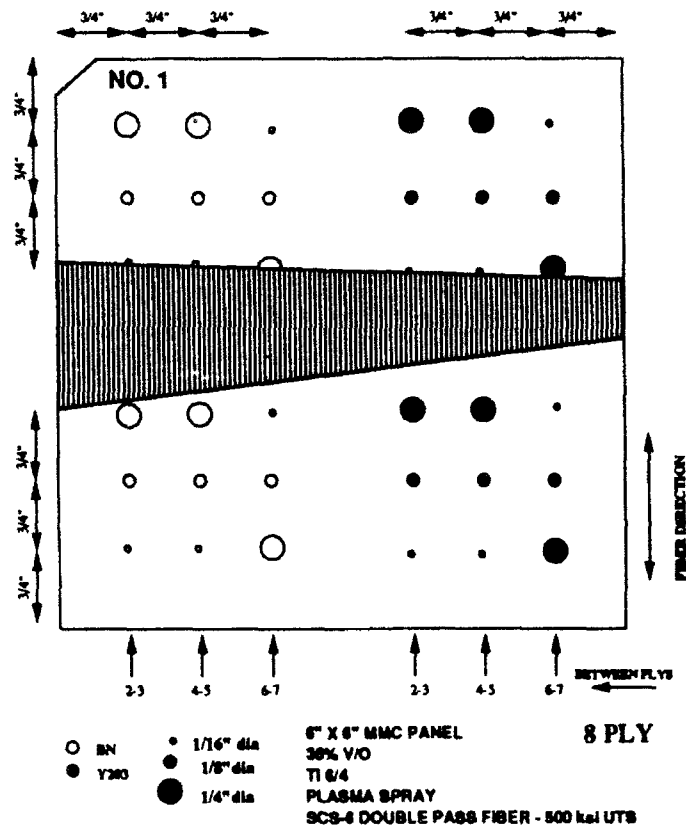
Figure 4.1 MMC panel 1 with delaminations.

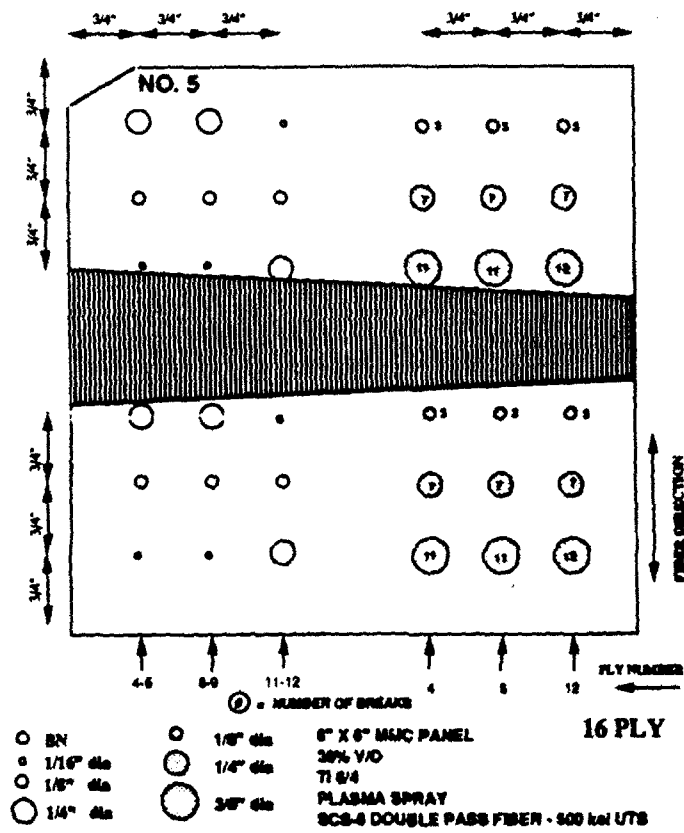
Figure 4.2 MMC panel 5 with delaminations and broken fibers.

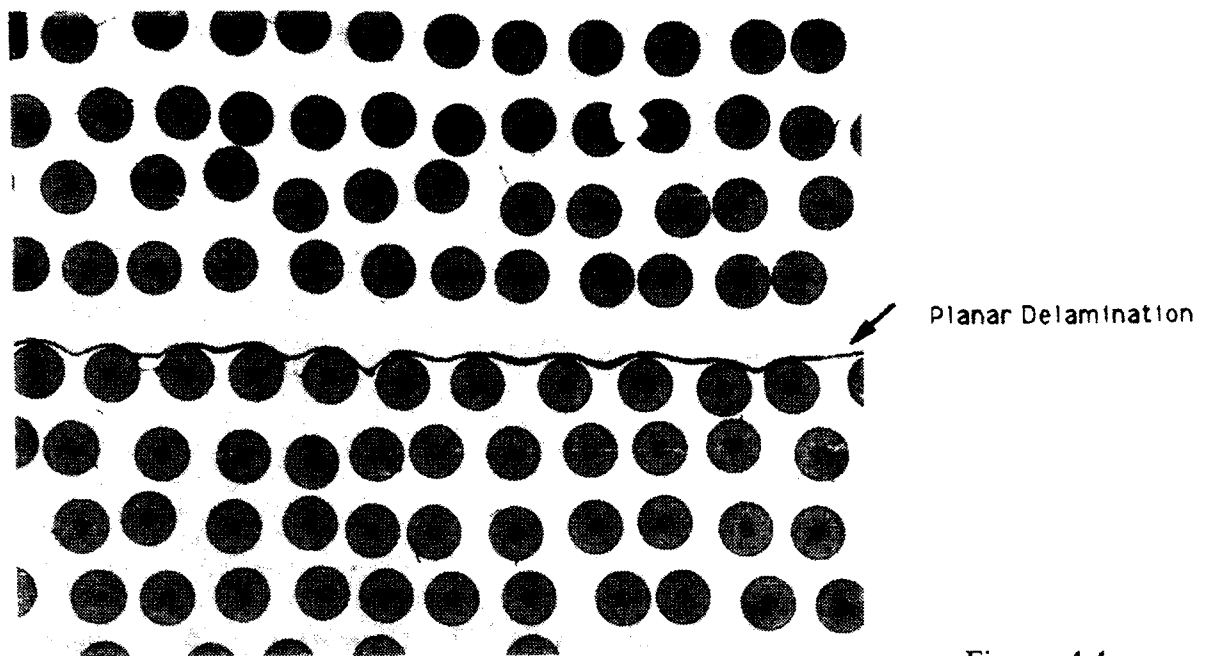
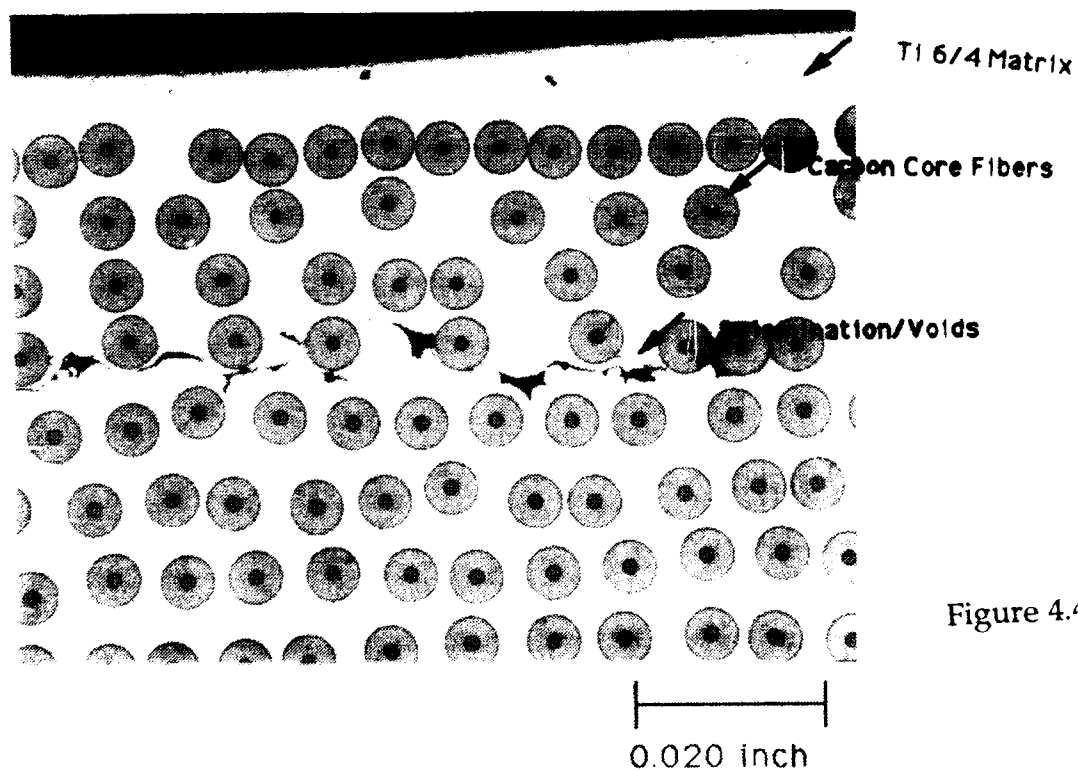
Figure 4.4 Cross sections of boron nitride induced delaminations in SiC/Ti MMC panel 1. Figure 4.4.a represents the intended planar delamination, while Figure 4.4.b shows how some delaminations split to form voided regions.

Another class of structures/defects is the air-backed interface. Delaminations, voids, fiber/matrix debonds and cracks fall into this category. Each of these conditions can be characterized as a transition from a solid (either titanium or silicon carbide) to air. This interface is a perfect reflector, and thus all of the incident sound energy is reflected. The image resulting from this type of structure can suggest the source of the indication. If the indication falls on a fiber, then it may be linked to the fiber, such as a fiber/matrix debond, (Figure 5.3) or fiber crack, (Figure 4.14). If the indication is between fibers, then it must be matrix-based, such as a void, (Figure 5.4). If the indication covers an area larger than the fiber diameter, then it is likely due to a delamination, (Figure 5.5). Photographs of the actual delaminations are shown in Figures 4.4 and 4.5.

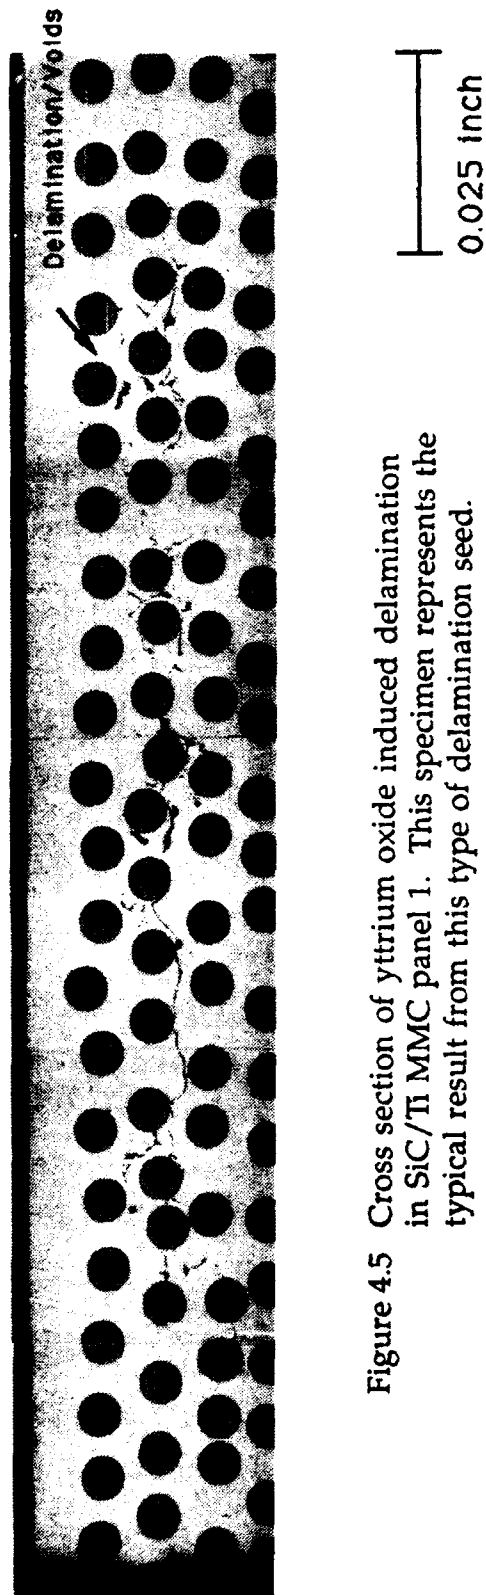
Figure 4.5 Cross section of yttrium oxide induced delamination in SiC/Ti MMC panel 1. This specimen represents the typical result from this type of delamination seed.

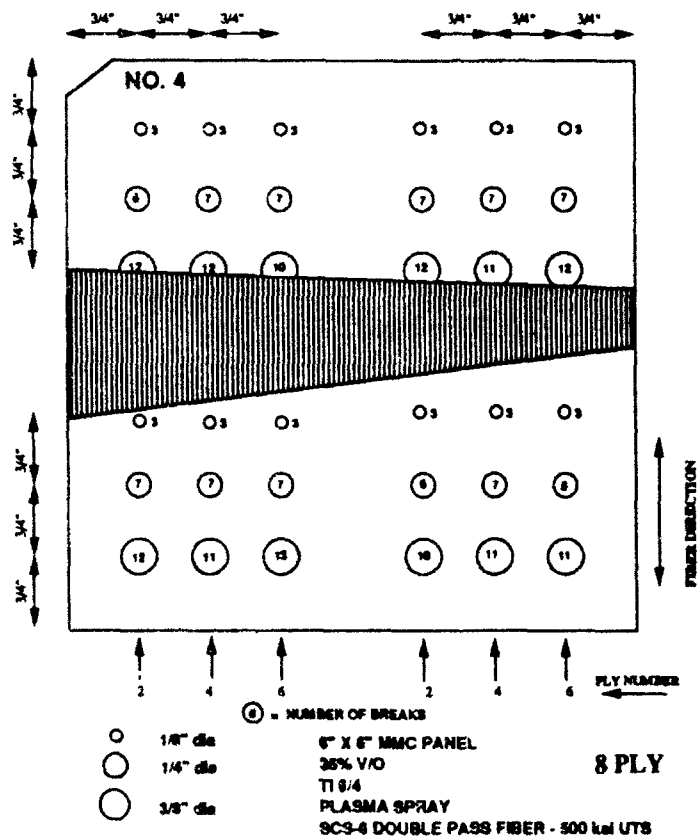
Figure 4.12 MMC panel 4 with broken fibers.

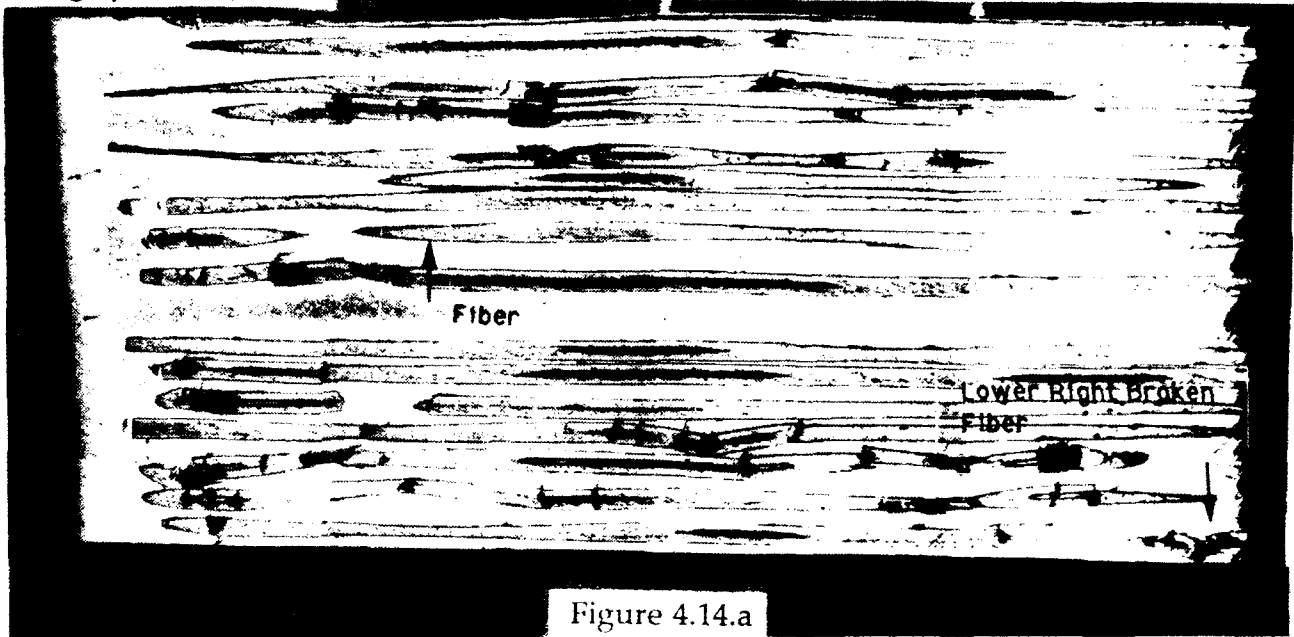
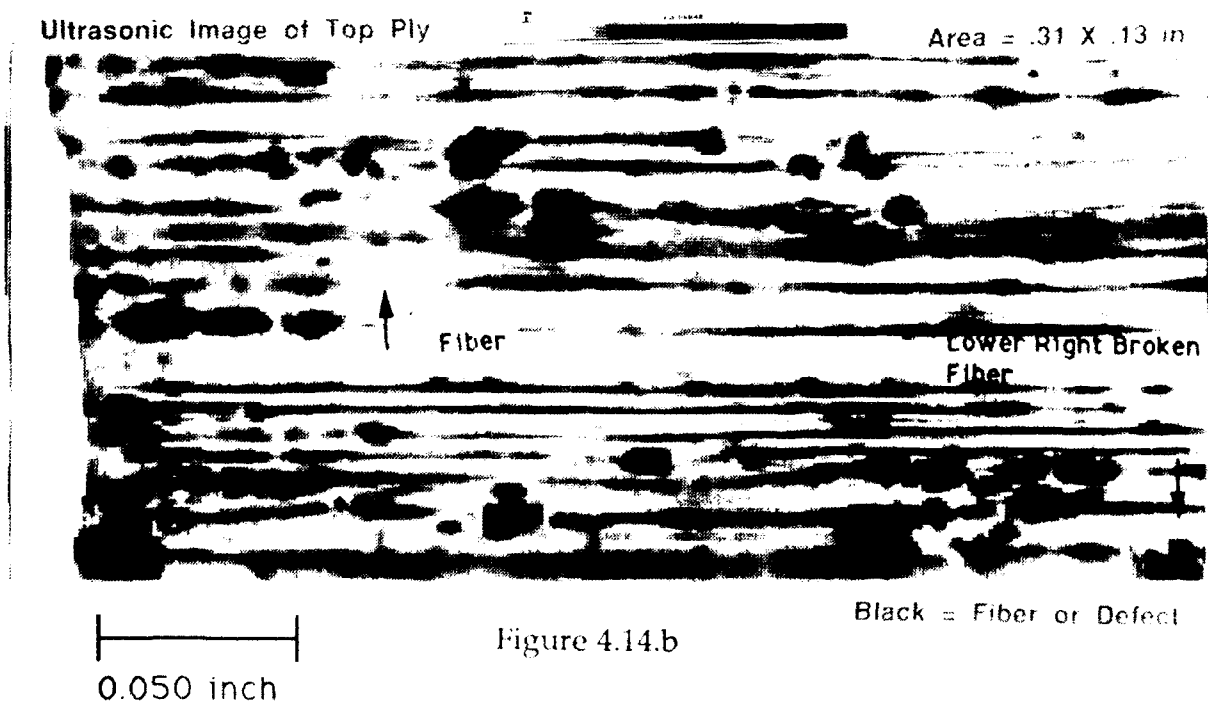
Figure 4.14 Correlation between acoustic microscope indications and broken fibers in SiC/Ti MMC panel 2. Figure 4.14.a shows the typical incidence of broken fibers in the MMC panels made for this program. Figure 4.14.b is the corresponding acoustic microscope image, made prior to the removal of the Titanium outer layer. This demonstrates the detectability of broken fibers.

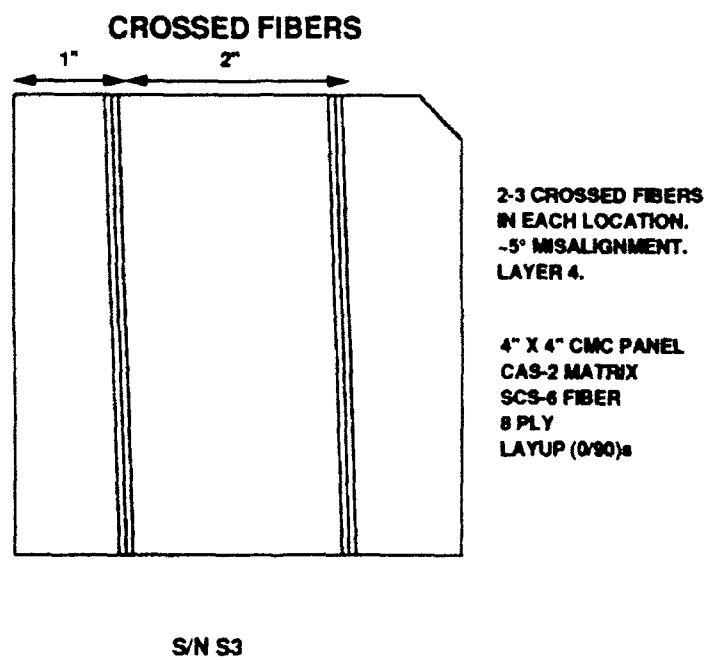
Figure 4.19 CMC panel S3 with misaligned fibers.

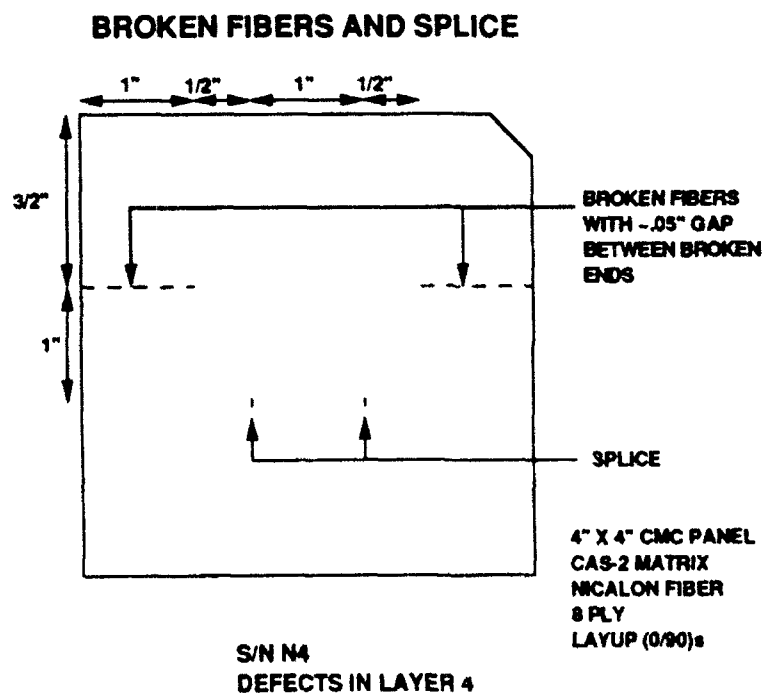
Figure 4.20 CMC panel N4 with broken fibers and splice.

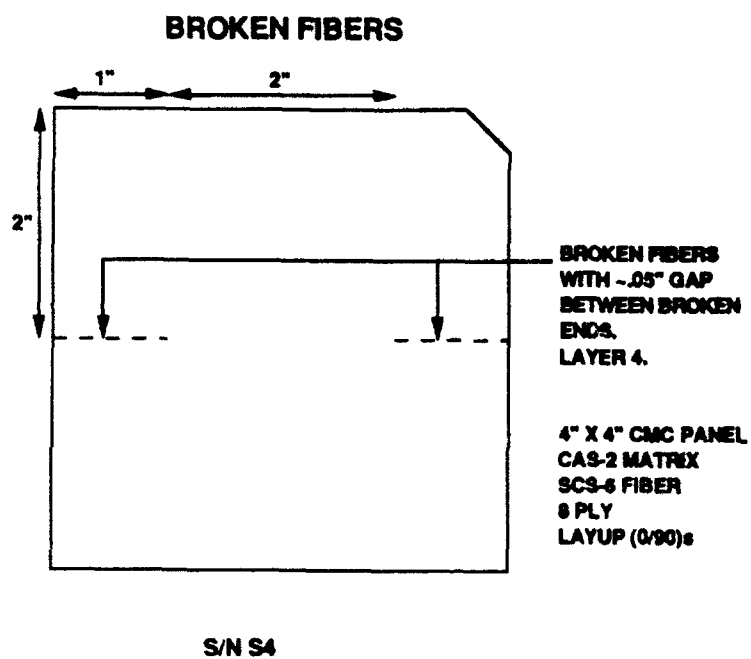
Figure 4.21 CMC panel S4 with broken fibers and splice.

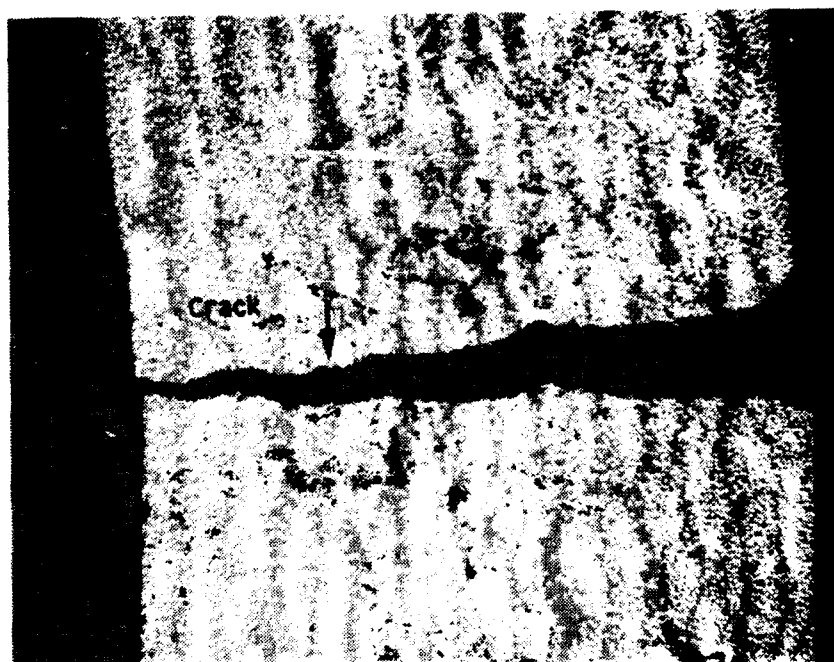
Figure 4.31 CAS/Nicalon CMC panel N11 showing a crack propagating along the fibers.

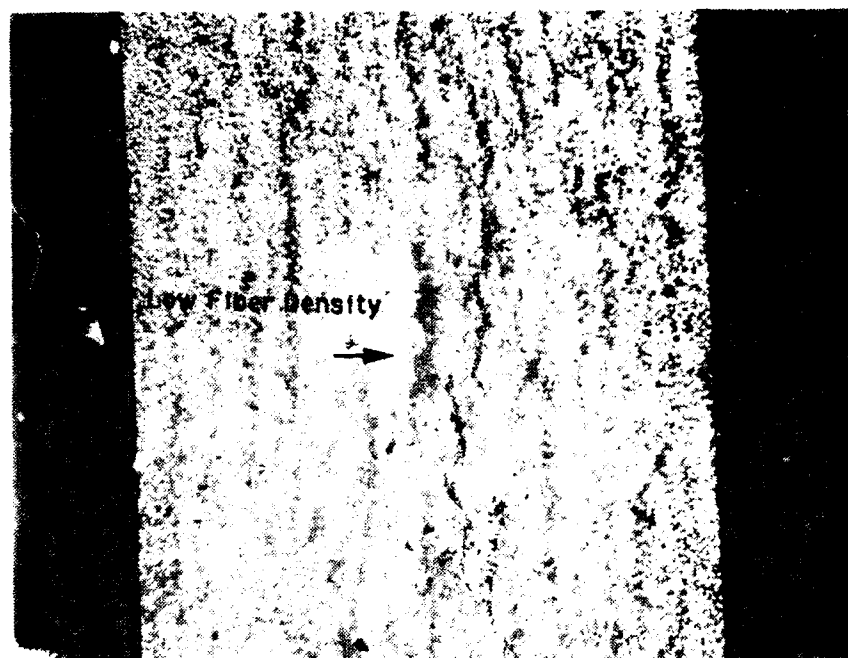
Figure 4.32 CAS/Nicalon CMC panel N12, with low porosity and uneven fiber distribution.

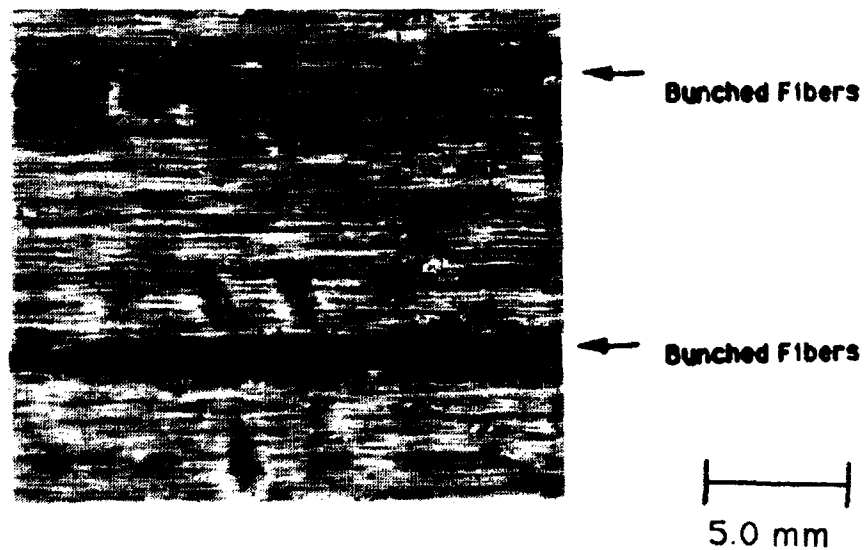
Figure 5.1 Acoustic microscope image of bunched fibers in SiC/Ti MMC panel 5. Upper band of fibers corresponds to Fig. 4.9.a. Lower band corresponds to Fig. 4.9.b.

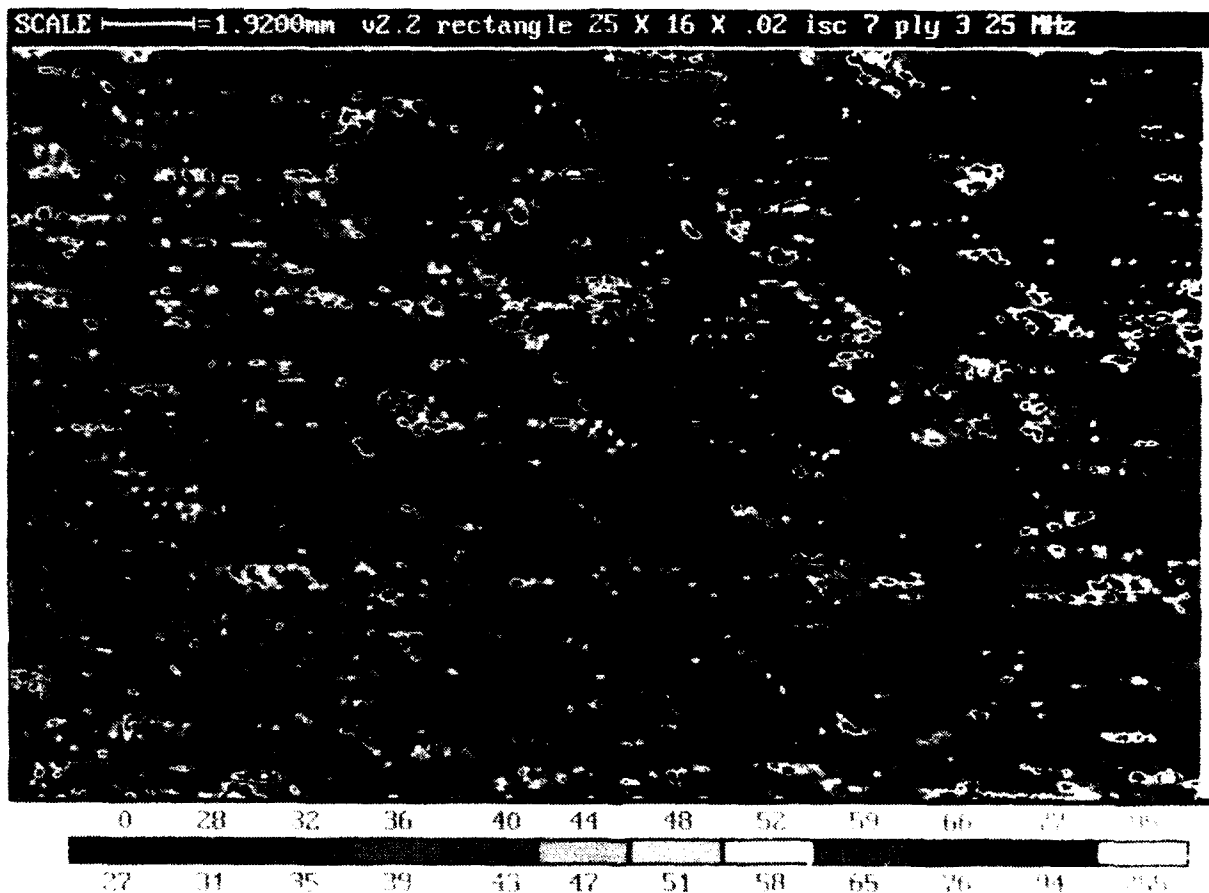
Figure 5.2 Acoustic microscope image of third ply in SiC/Ti MMC panel 7. Fiber orientation is -45 degrees, as viewed through two outer plies at zero degrees.

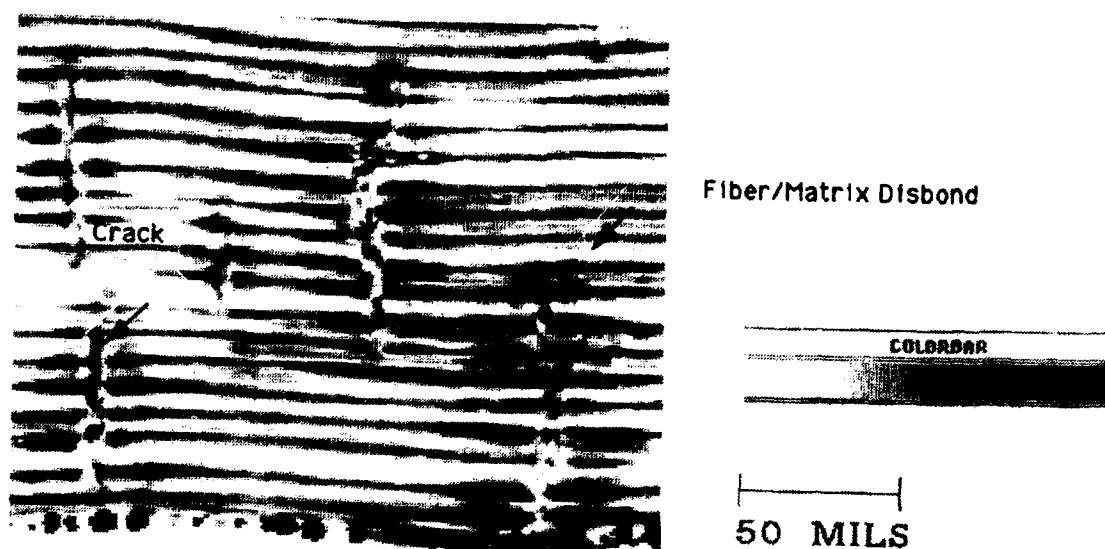
Figure 5.3 Acoustic microscope image of cracks and fiber/matrix debonds in SiC/TI MMC specimen.

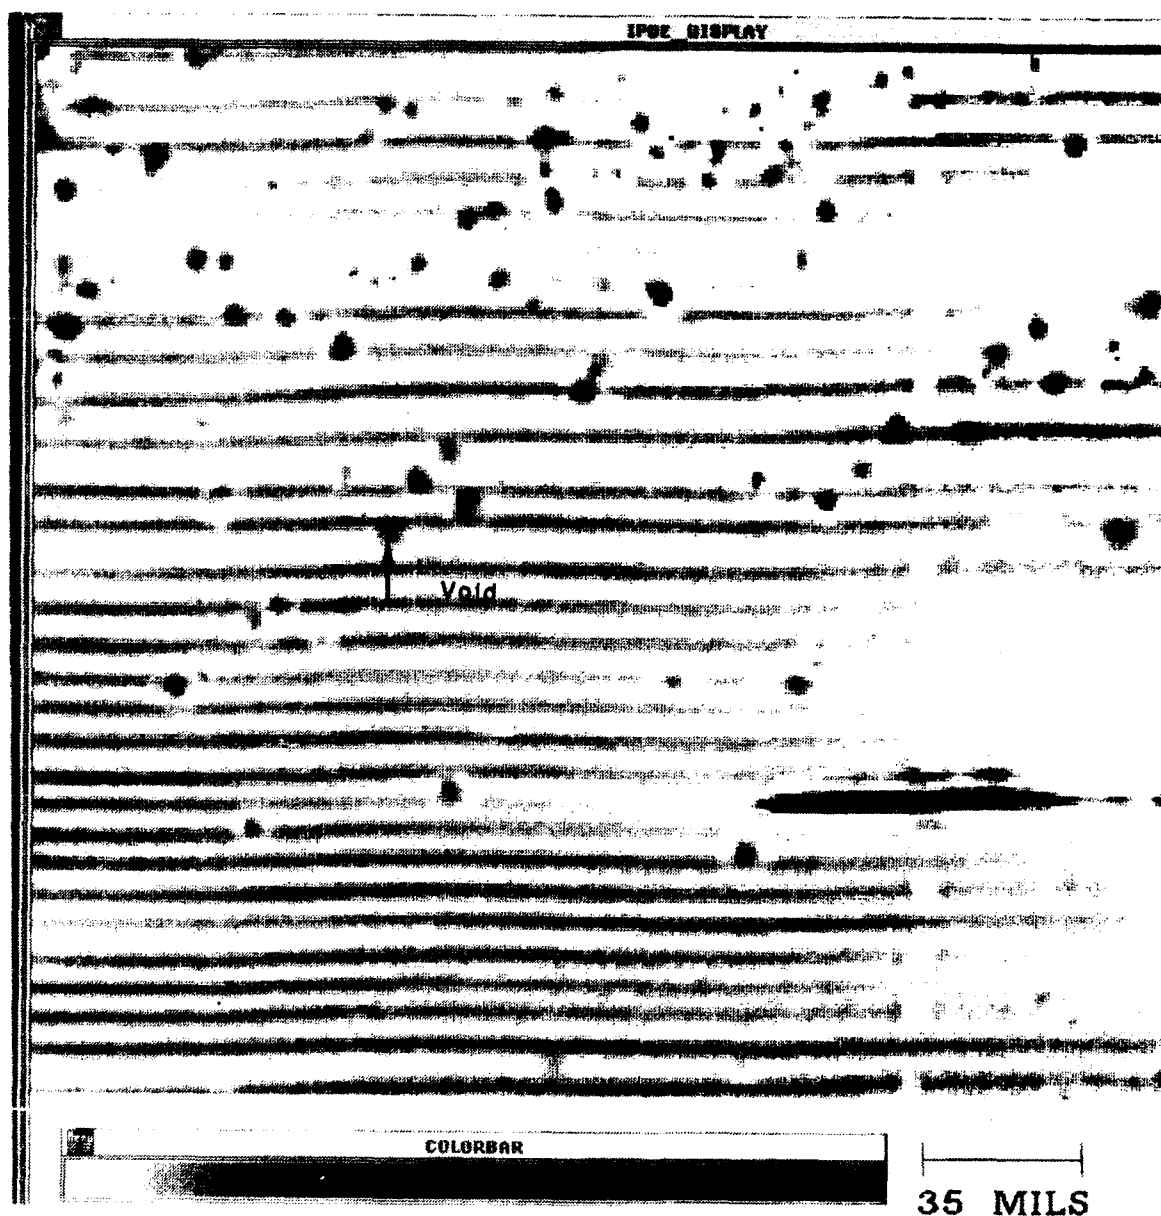
Figure 5.4 Acoustic microscope image of pores in SiC/Ti MMC specimen.

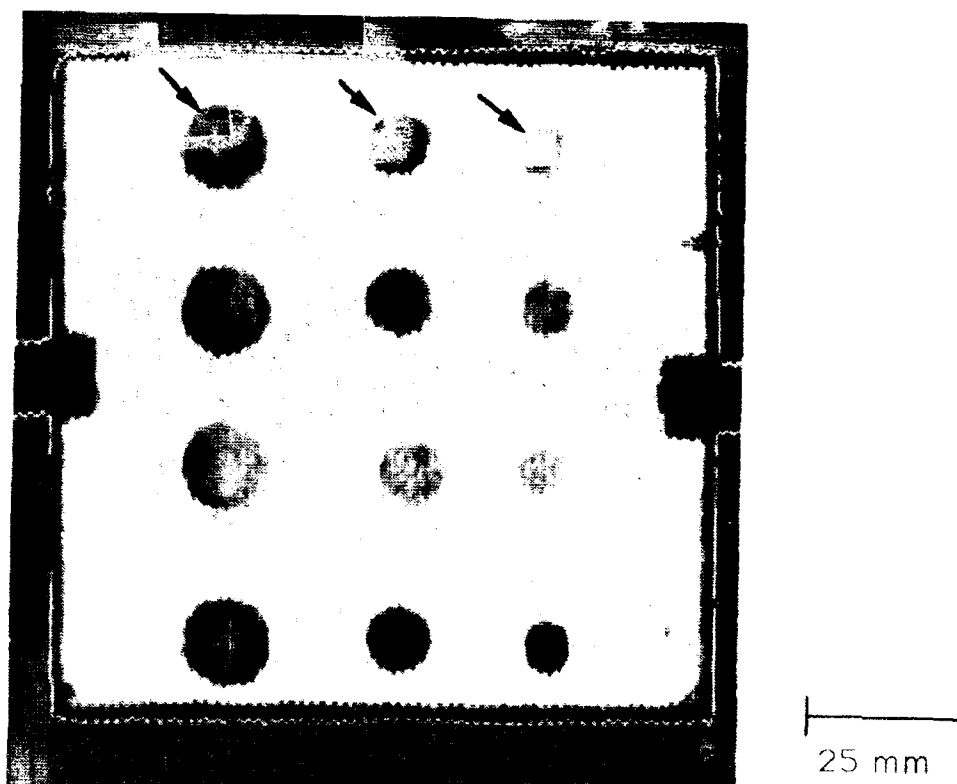
Figure 5.7 Ultrasonic through-transmission image of CAS/Nicalon CMC panel N1 showing delaminations. Black circles represent delaminations.

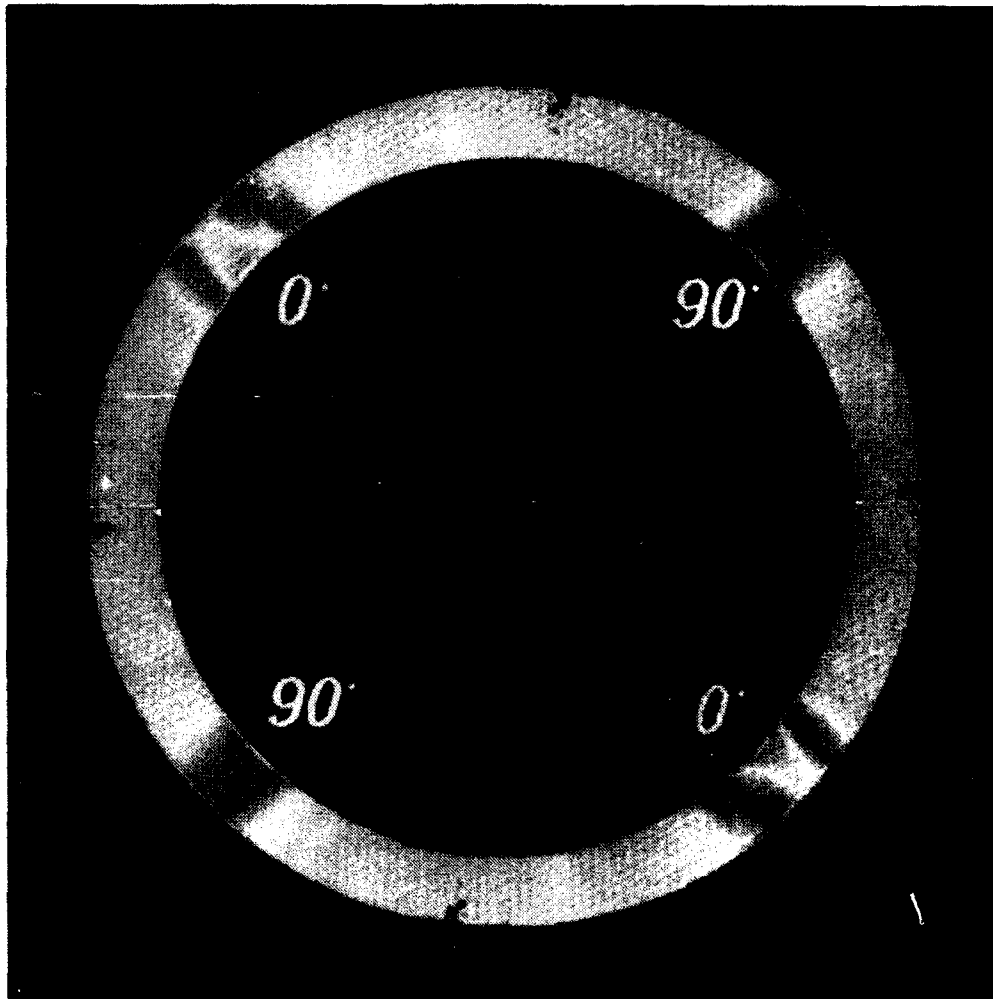
Figure 5.12 Ultrasonic polar backscatter scan showing 0/90 degree fibers in a CAS/Nicalon panel. Angular dimension of plot corresponds to rotational angle of transducer assembly. Radial dimension of plot corresponds to the angle of incidence of sound to the panel, with the inner value at 10 degrees and the outer value at 20 degrees.

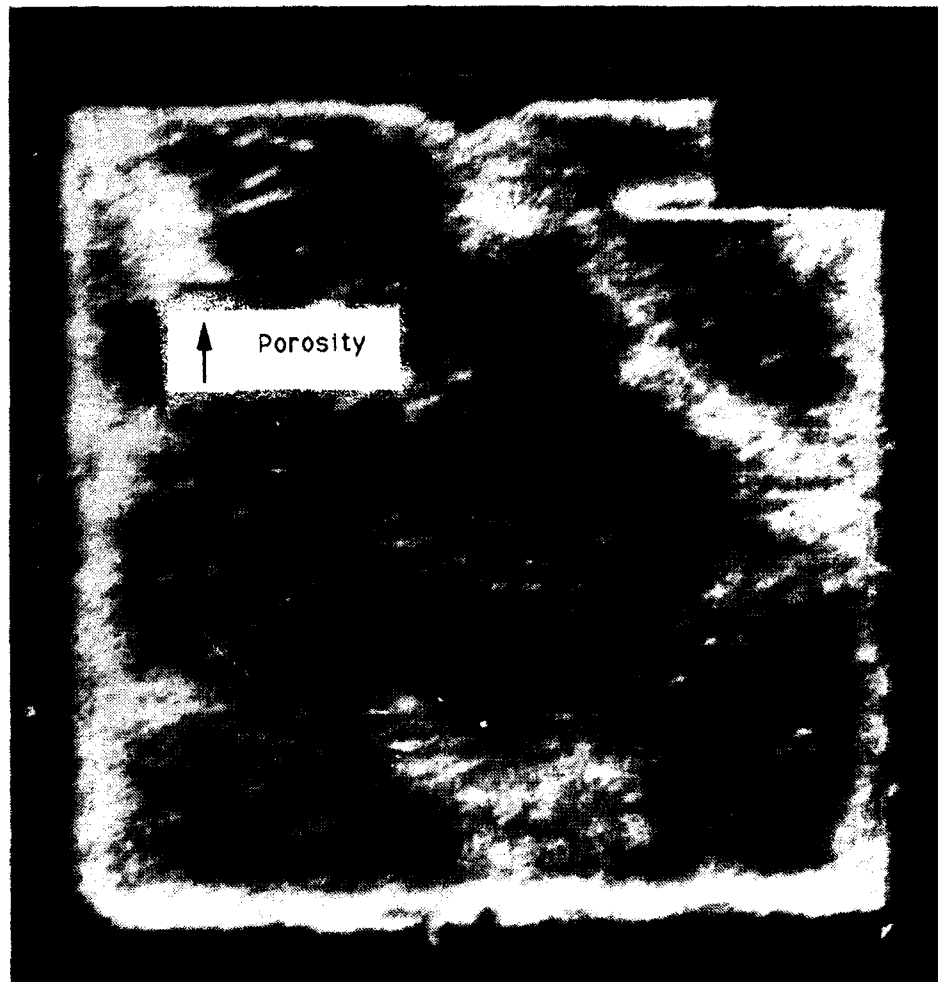
Figure 5.13 Ultrasonic backscatter scan of CAS/Nicalon CMC panel N6 showing moderate porosity. White indications correspond to higher porosity.

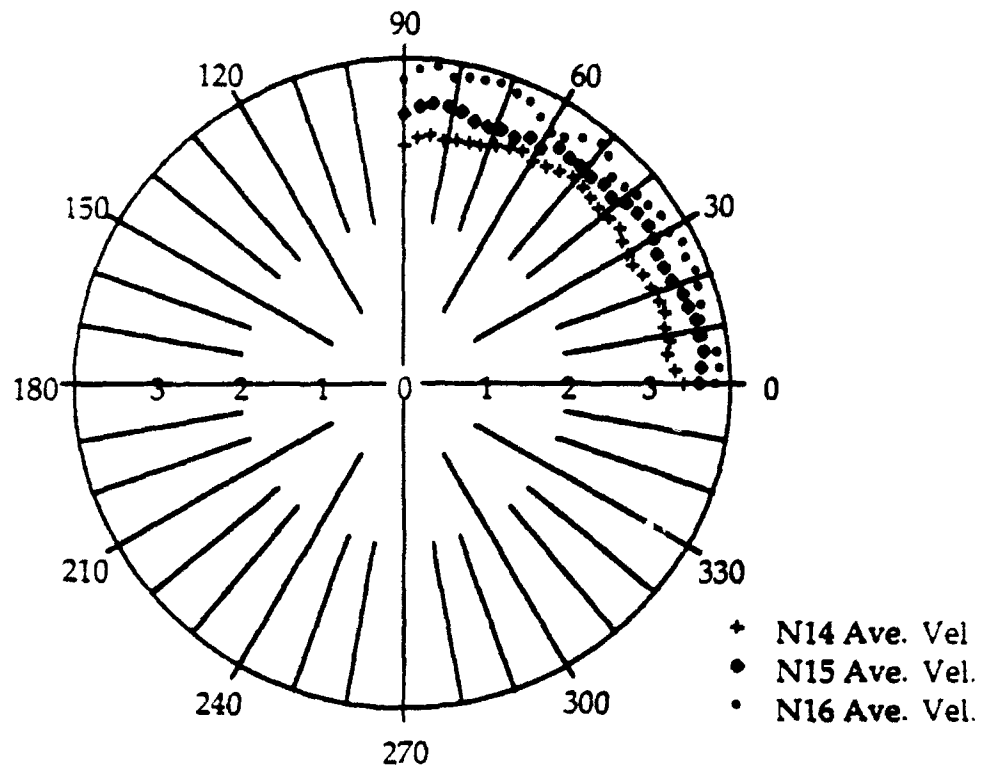
Figure 5.14 Polar plot of surface wave velocity for CAS/Nicalon panels N14, N15, and N16. Velocity increases with fiber volume fraction and tends to be higher along the direction of fiber orientation (0 degrees). Angular dimension of plot corresponds to rotational angle of transducer assembly, and radial dimension corresponds to velocity.

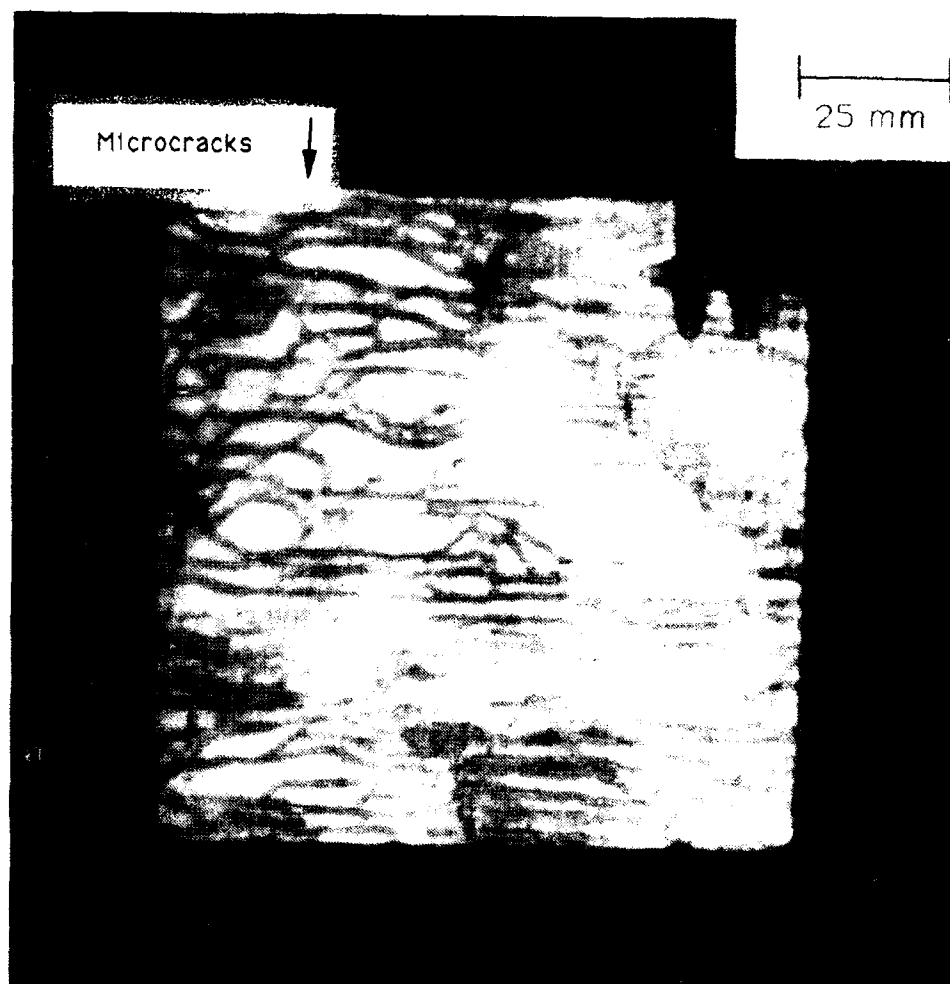
**Figure 5.15** Ultrasonic surface wave image of CAS/Nicalon panel N6 showing microcracks and moderate porosity. Black line indications are microcracks and the dark patch indications represent porosity.

Microcracks and variations in porosity in a CAS/Nicalon sample were easily detected using a 5-MHz transducer, as demonstrated by Figure 5.15. Other defects that attenuate sound in the ultrasonic through-transmission mode should also be detectable in the surface wave attenuation mode, as the same fundamental properties of detection are used. This technique is applicable for interrogating

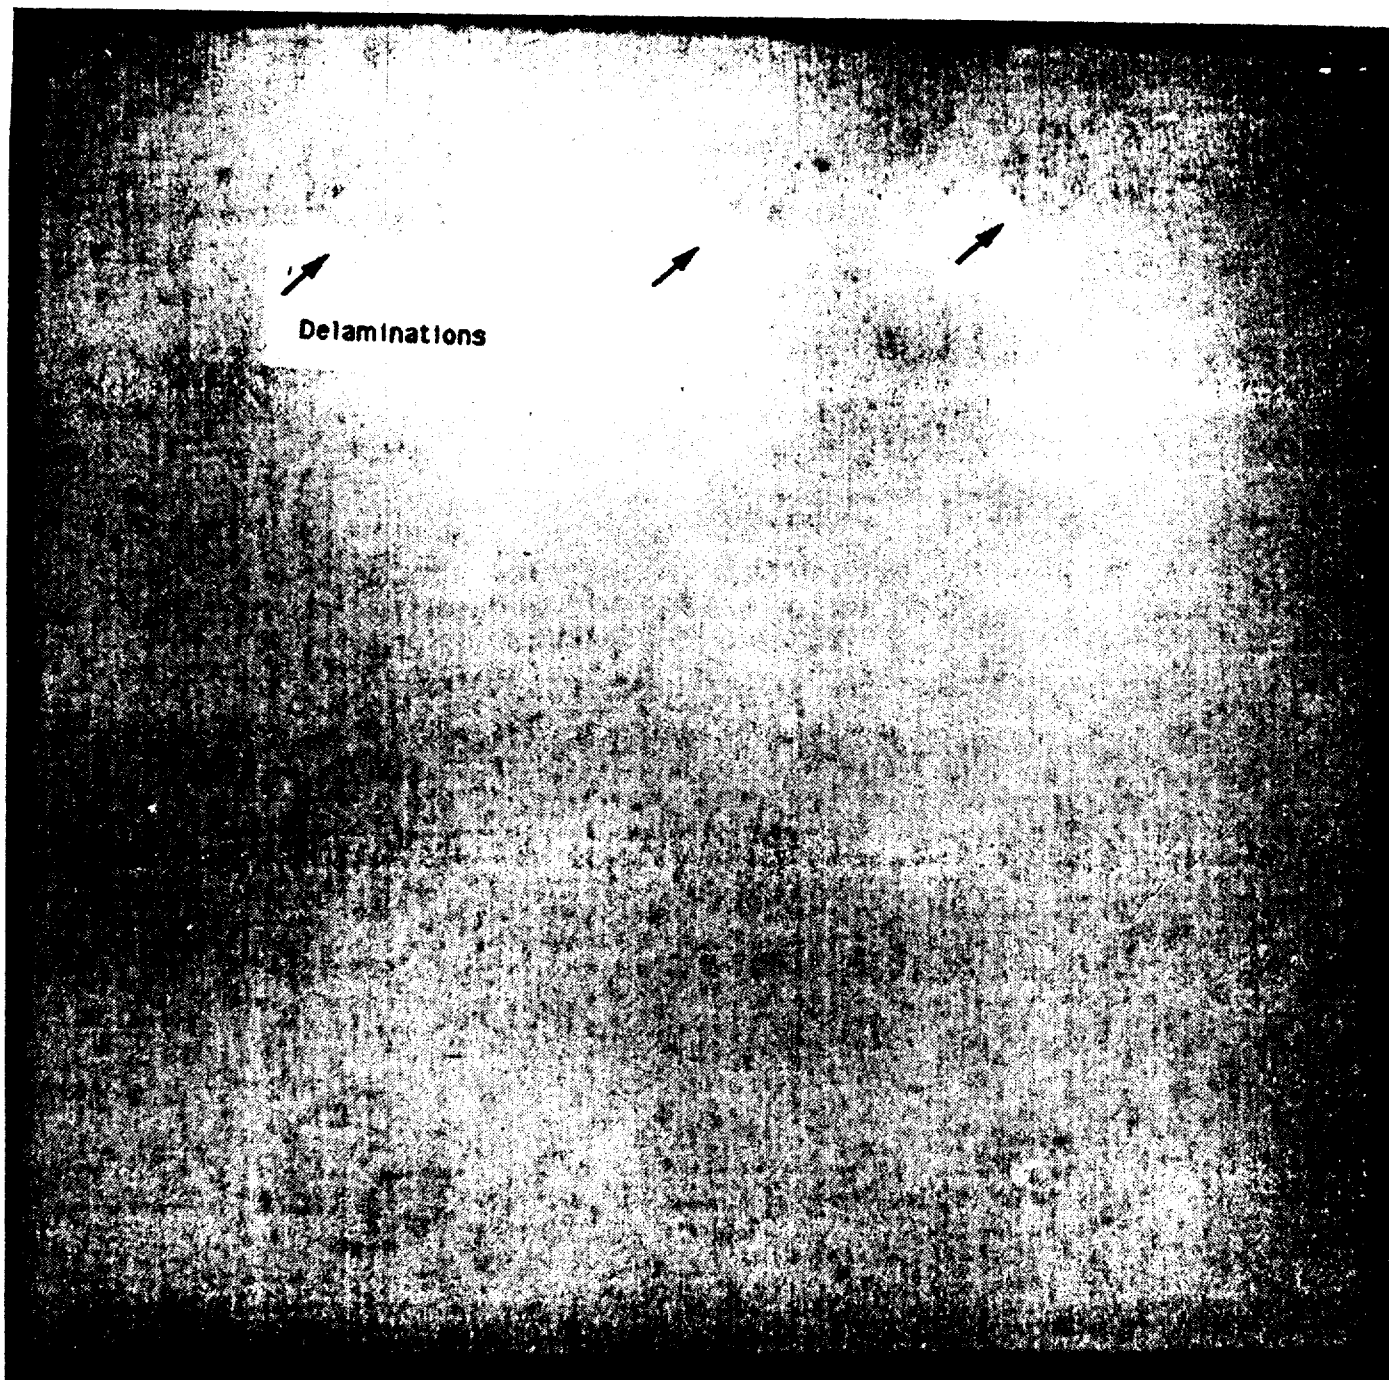
Figure 5.20 Film radiograph image of CAS/Nicalon CMC panel N1 showing delaminations. Dark circles are delaminations

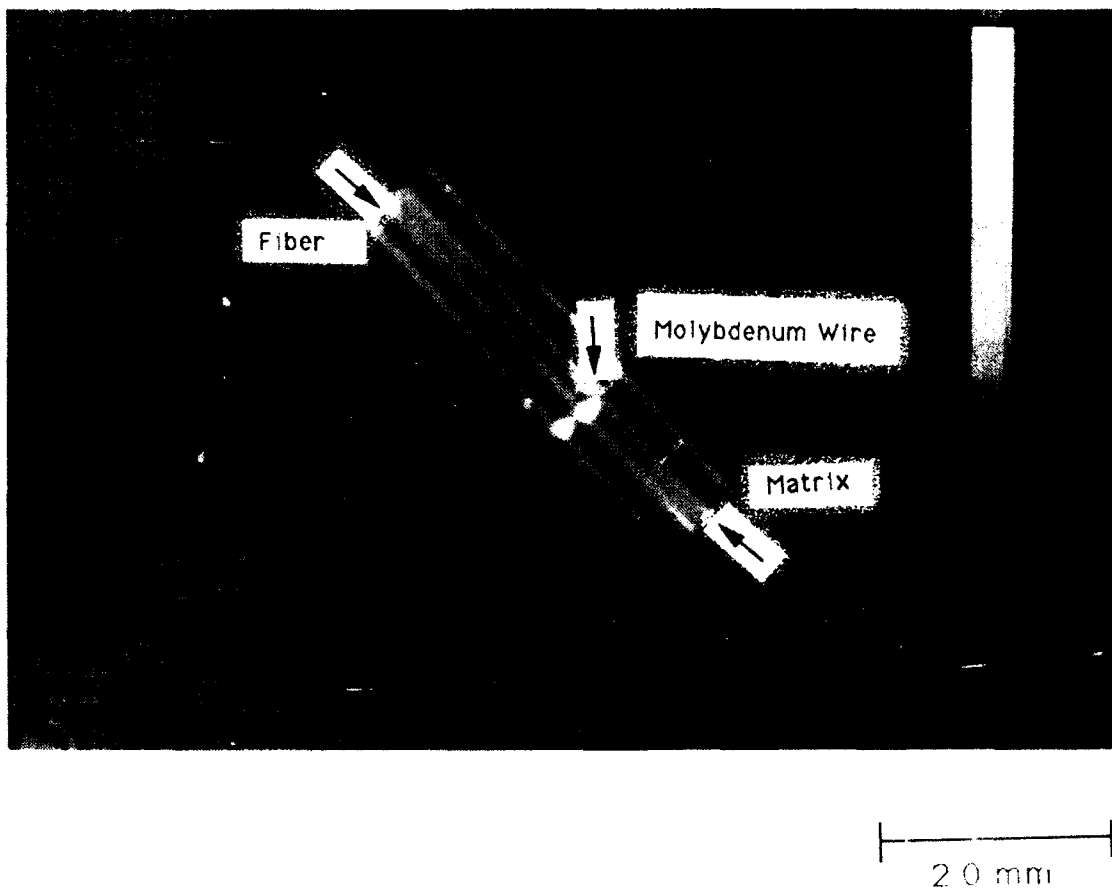
Figure 5.21 Microtomographic image of TiAl/SCS-6 sample, showing resolution of Tomoscope system for MMC structures.

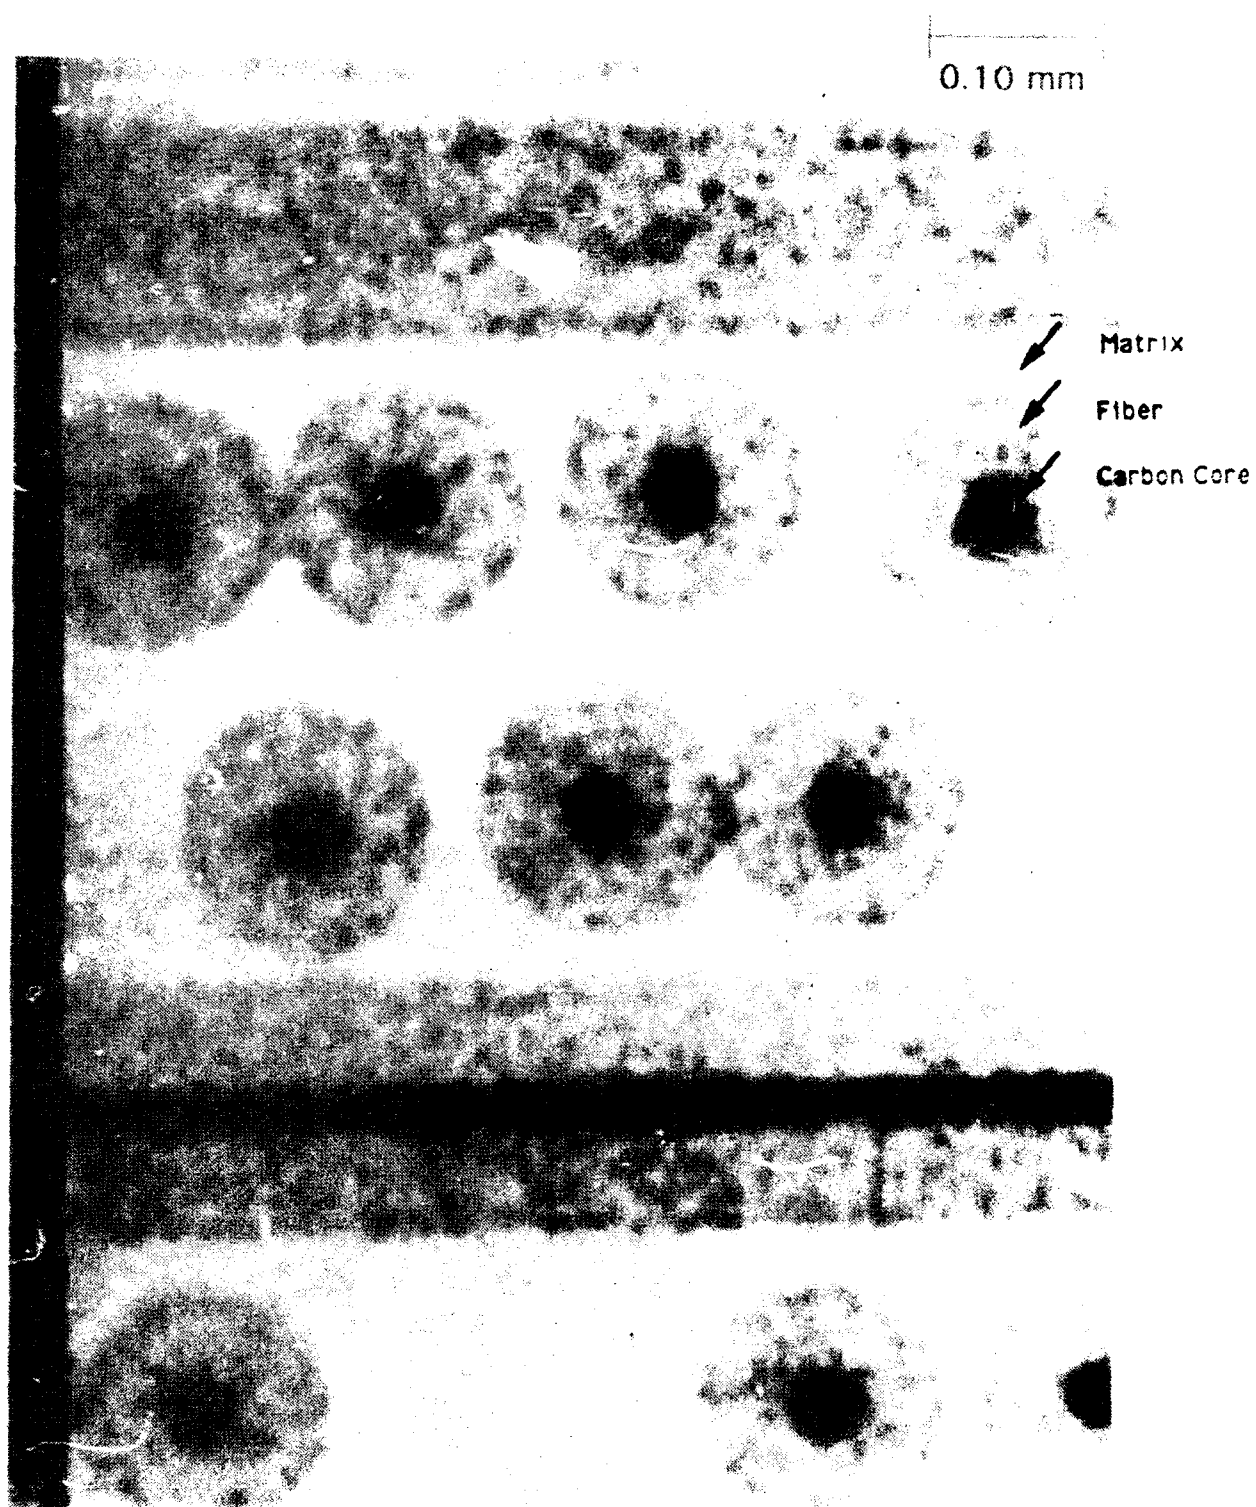
Figure 5.22 Synchrotron image of CAS/SCS-6 system, showing details as fine as the fiber core
